**Service  
Manual**

# hp StorageWorks Edge Switch 2/24

**Product Version:** FW v06.xx/HAFM SW v08.02.00

**Part Number:** AA-RTDXC-TE

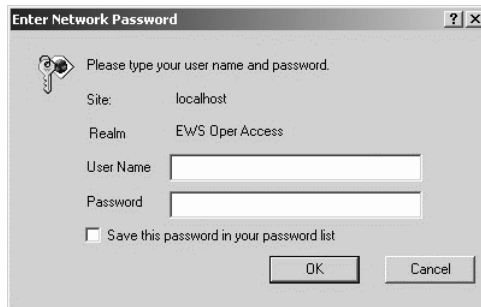
**Figure 4: Username and Password Required dialog box**

1. Power on the PC in accordance with the instructions delivered with the PC. The Windows desktop appears.
2. Launch the PC browser application by double-clicking the Netscape Navigator icon or Internet Explorer icon at the Windows desktop.
3. At the **Netsite** field (Netscape Navigator) or **Address** field (Internet Explorer), type `http://xxx.xxx.xxx.xxx`, where `xxx.xxx.xxx.xxx` is the IP address of the switch (obtained in [step 1](#)). The Username and Password Required dialog box appears ([Figure 4](#)).
